**Monitoring and Maintenance
Plan
Former James Mangan Park
Rifle & Pistol Range**

2140 34th Avenue
Sacramento, CA 95822
Stantec PN: 185704364

August 20, 2019

**MONITORING AND MAINTENANCE PLAN
FORMER JAMES MANGAN PARK RIFLE & PISTOL RANGE**

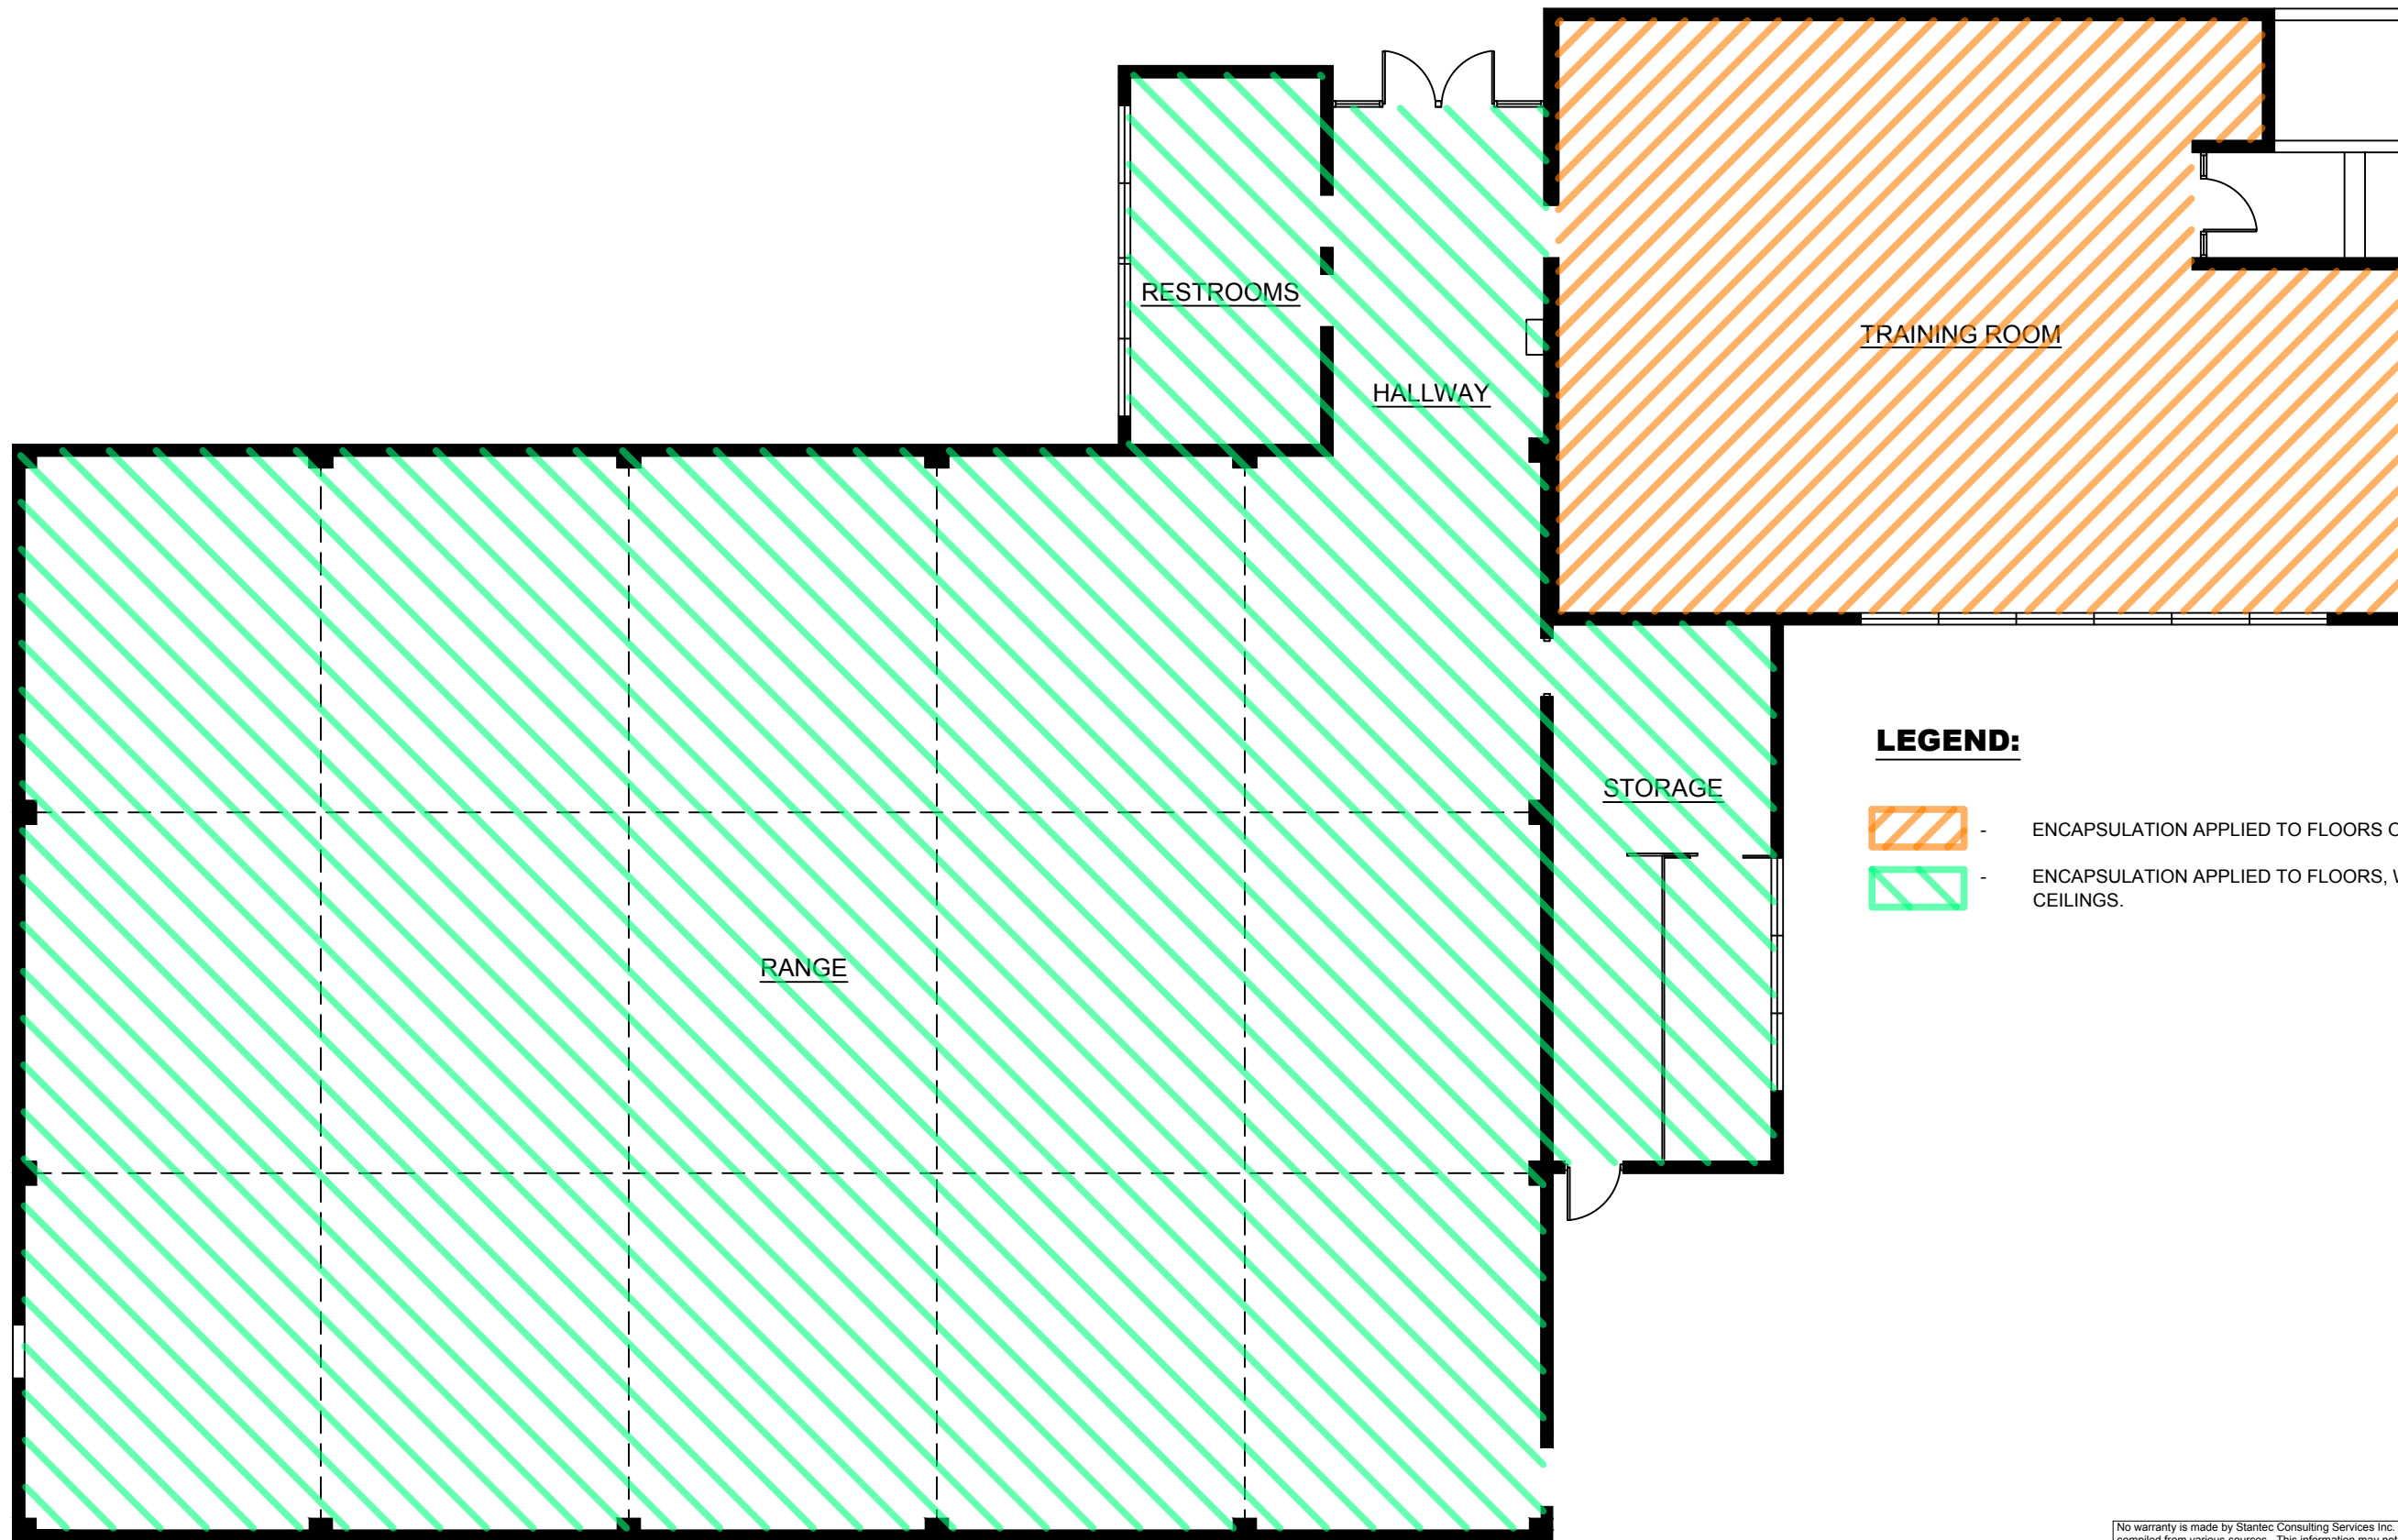
FOR: CITY OF SACRAMENTO FORMER MANGAN PISTOL & RIFLE RANGE 2140 34th AVENUE SACRAMENTO, CA. 958322-3157		INTERIOR LEAD CONTAINING MATERIALS		FIGURE: 1
	JOB NUMBER: 185704364	DRAWN BY: STA	CHECKED BY: DSM	APPROVED BY: NHD	DATE: 07/14/19

- ENCAPSULATION APPLIED TO FLOORS, WALLS, AND CEILINGS.

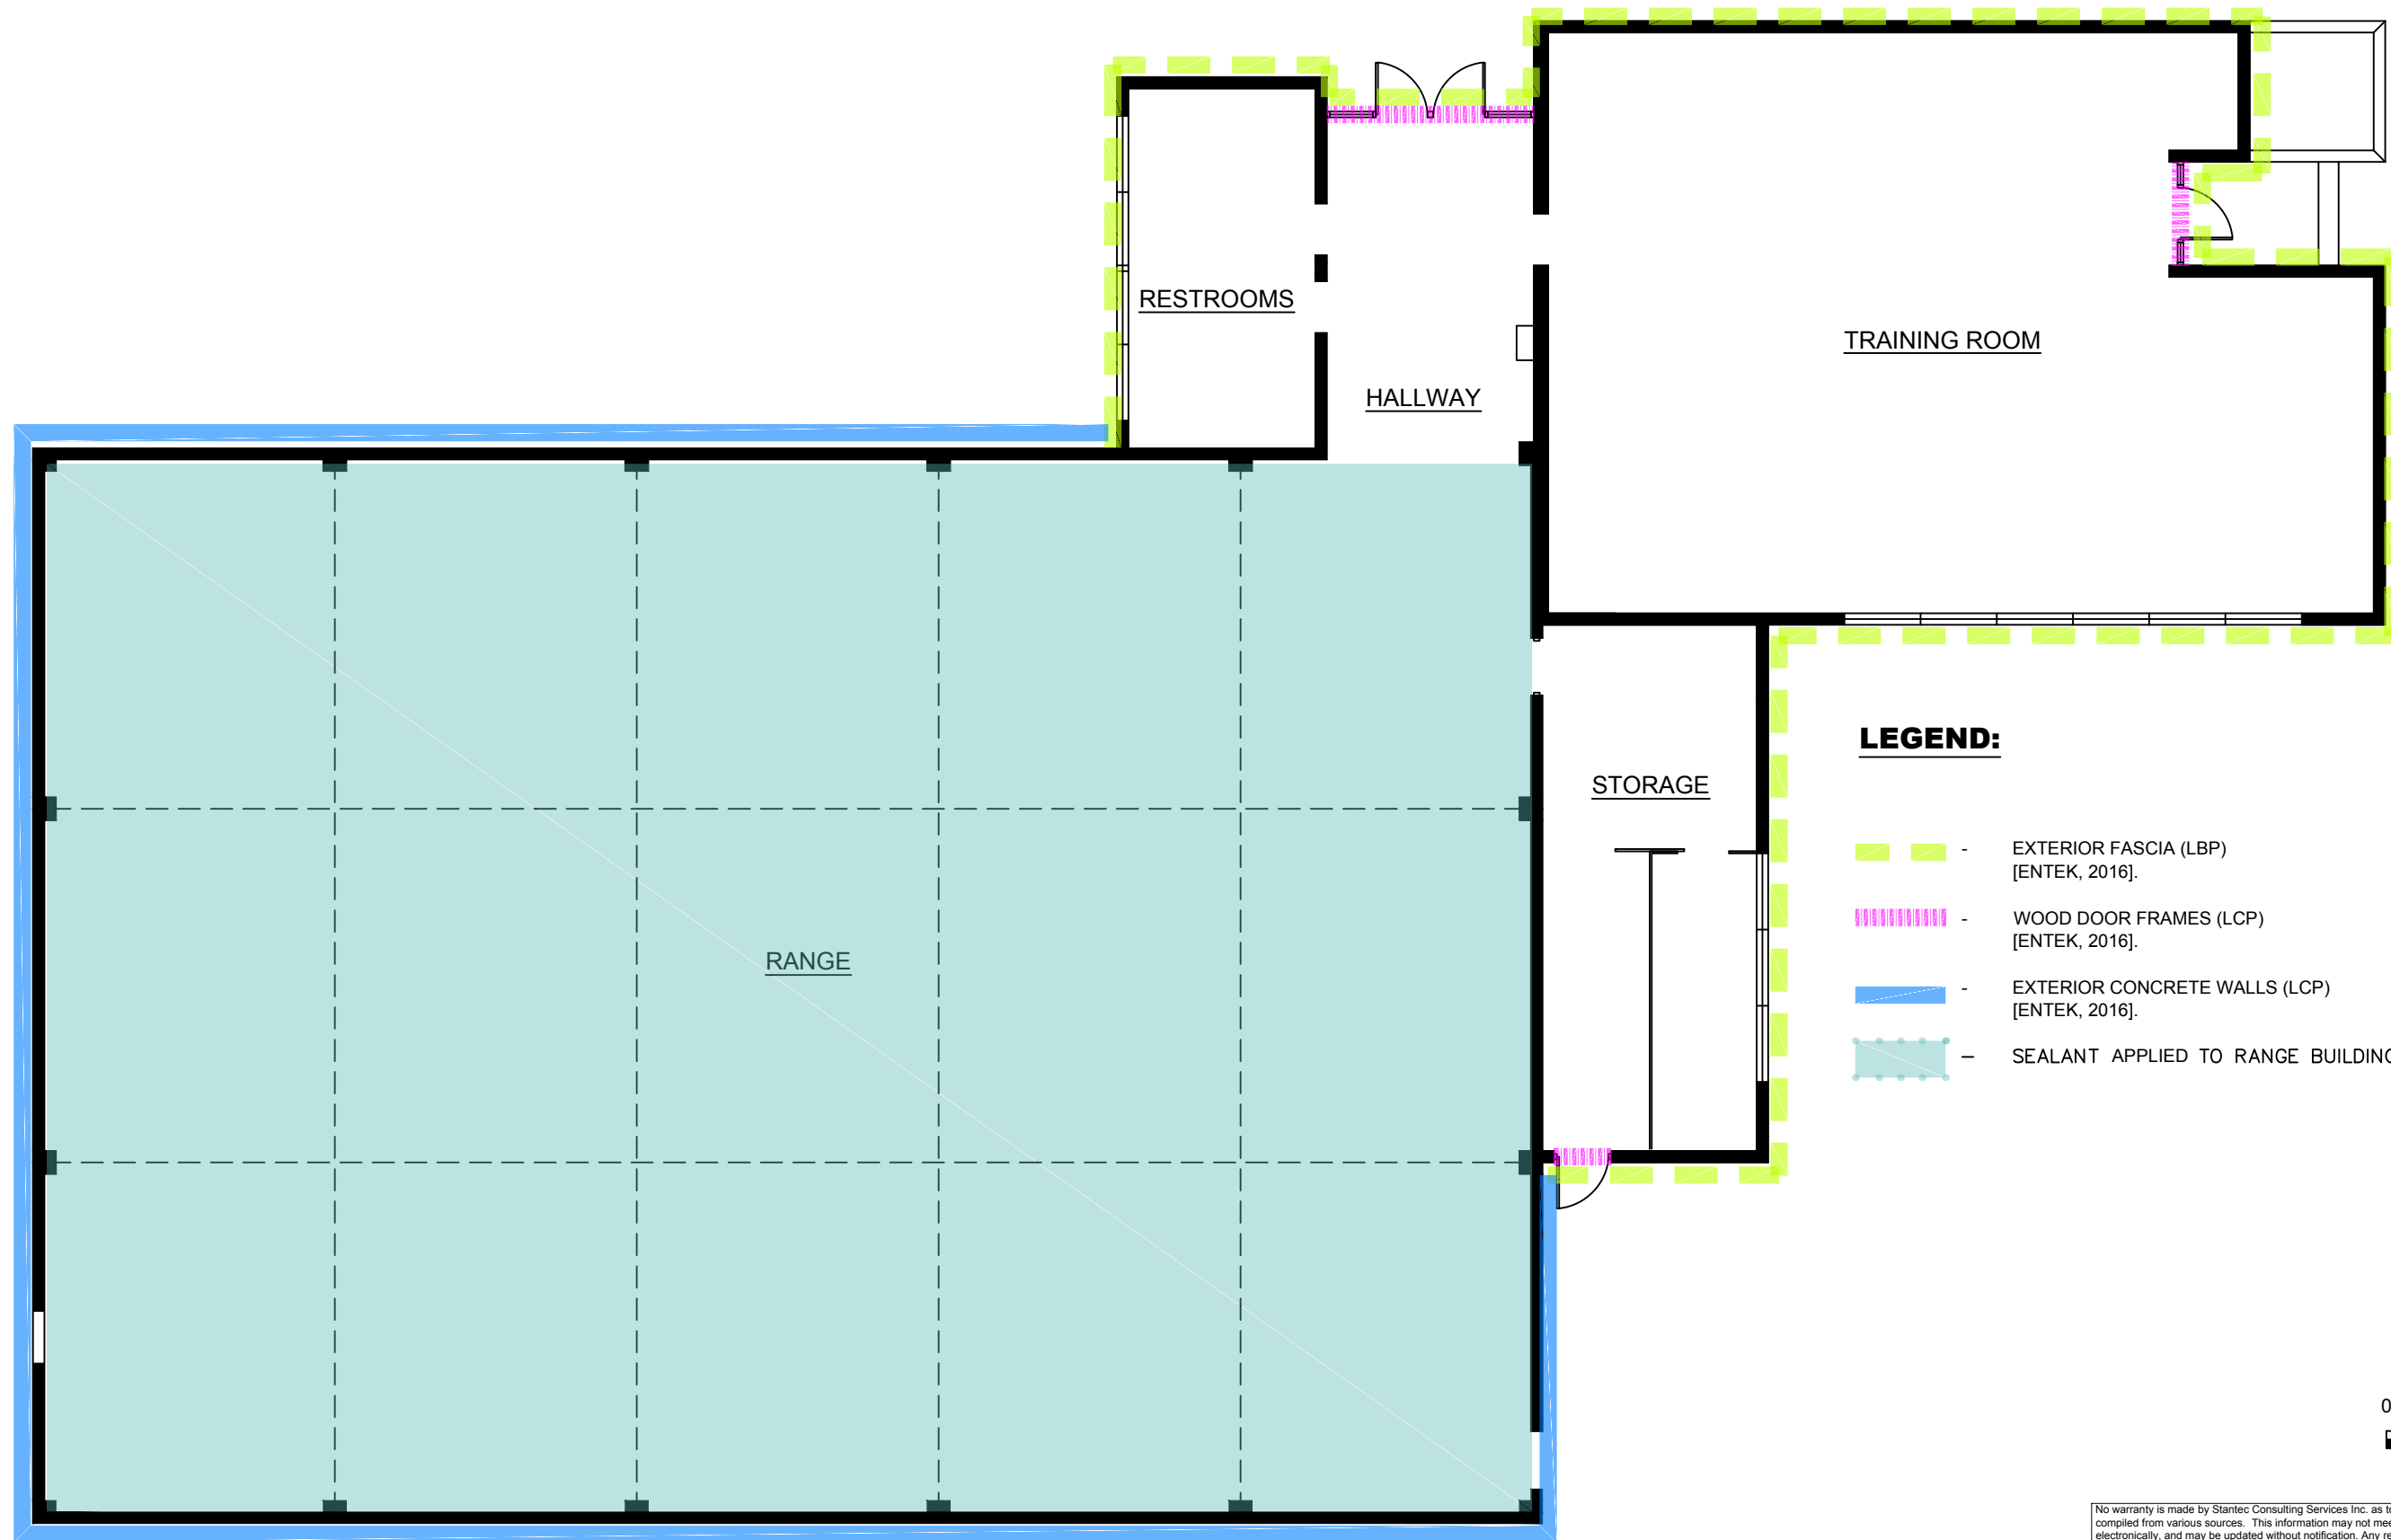
- SEALANT APPLIED TO RANGE BUILDING ROOF

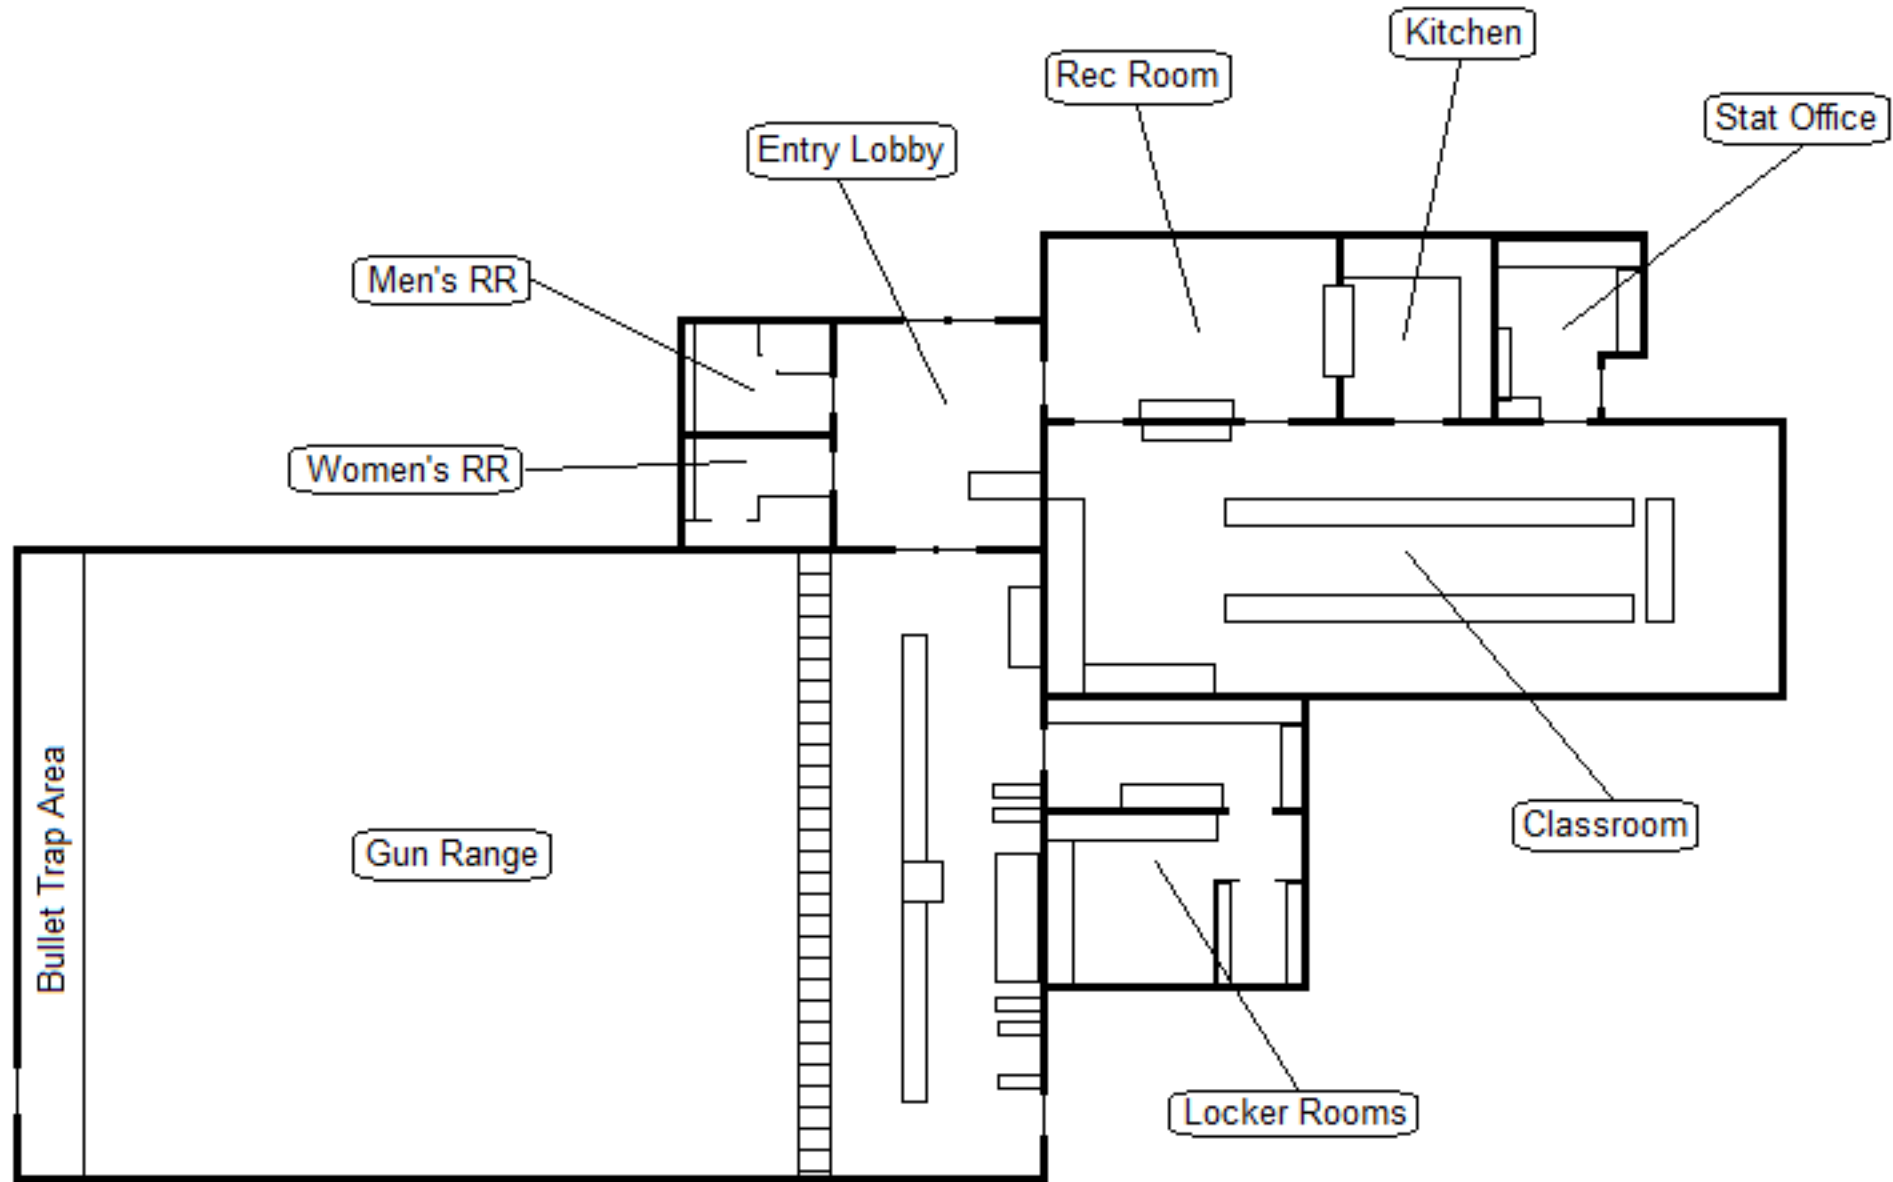
Lead Wipe Sample Location Diagram
Samples Collected by: Blake Howes
November 17, 2014
Project #14-3323

All Sample Locations Constitute a Lead Hazard as Defined by Title 17 & EPA

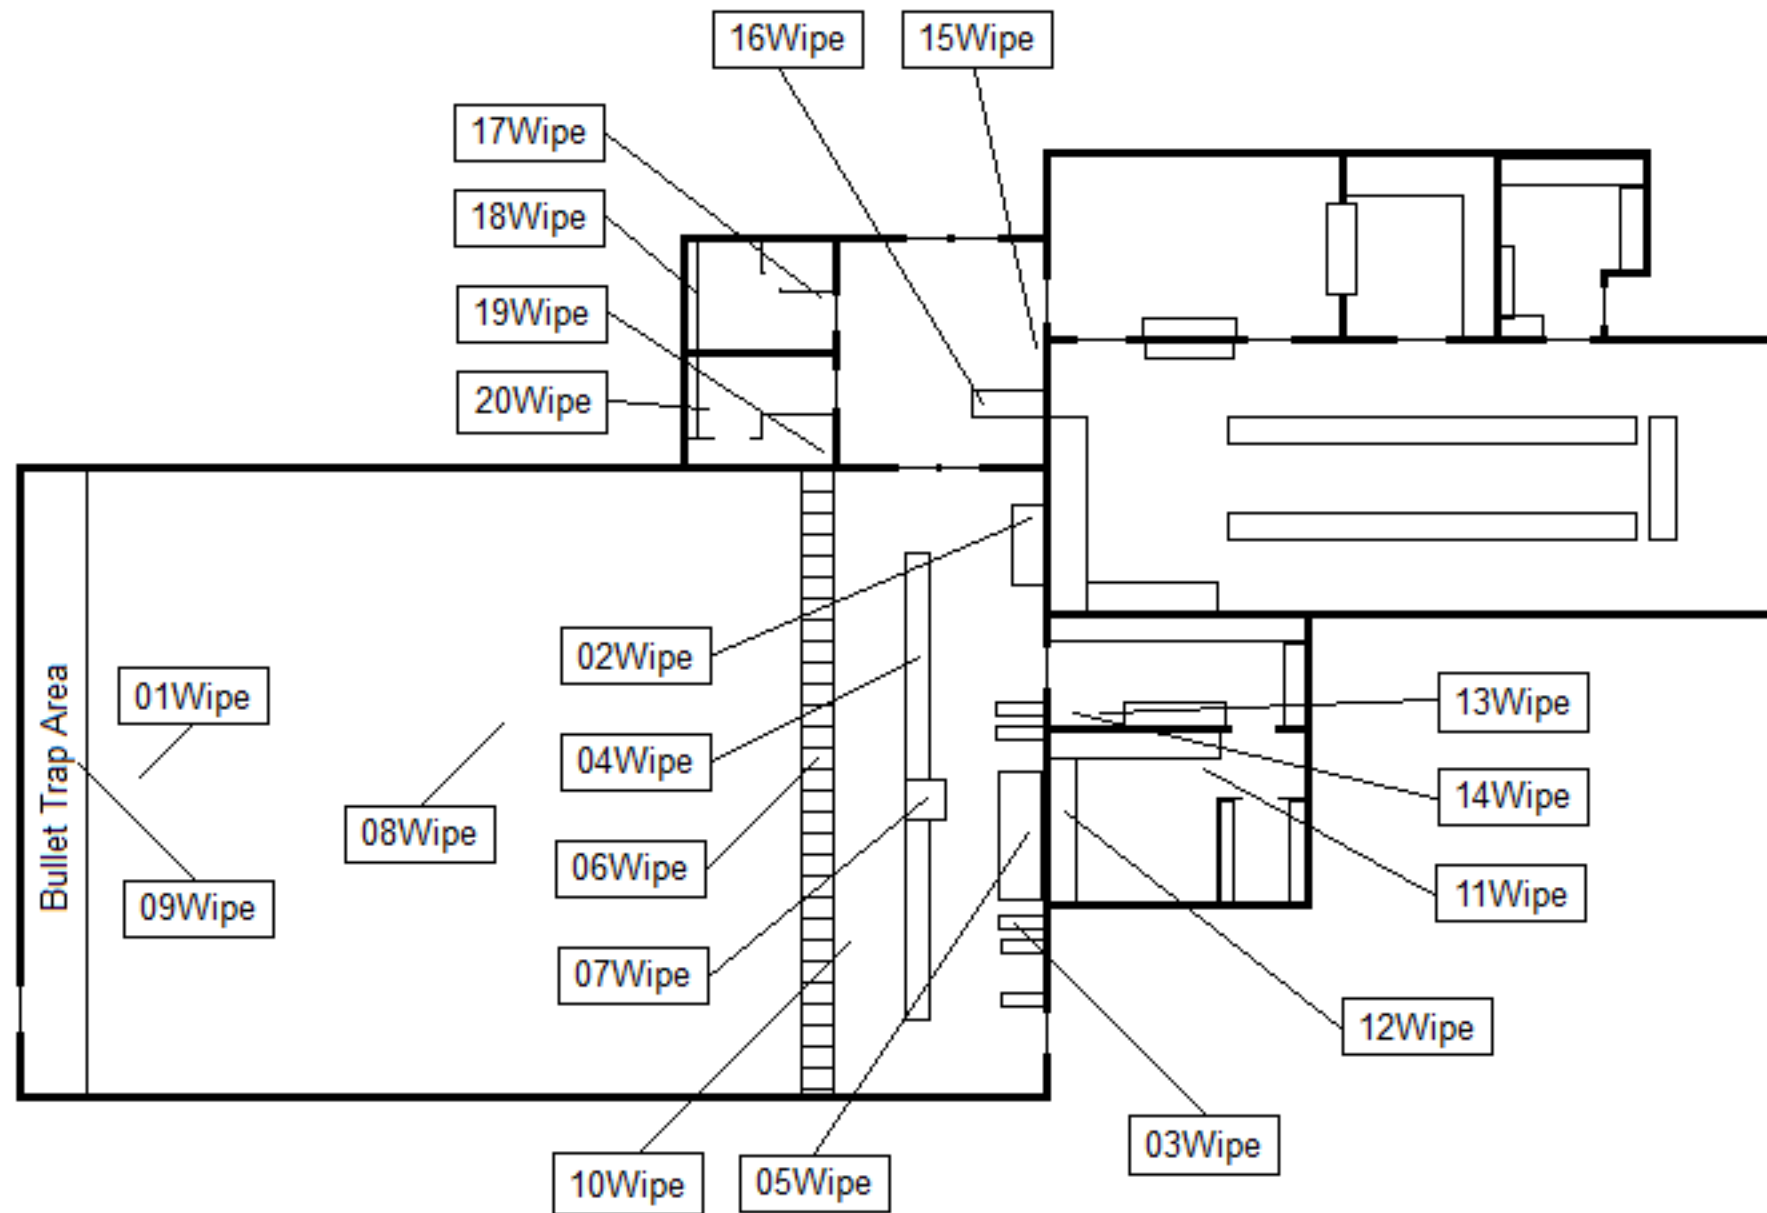
Lead Wipe Sample Location Diagram
Samples Collected by: Blake Howes
November 17, 2014
Project #14-3323

All Sample Locations EXCEPT 27Wipe Constitute a Lead Hazard as Defined by Title 17 & EPA

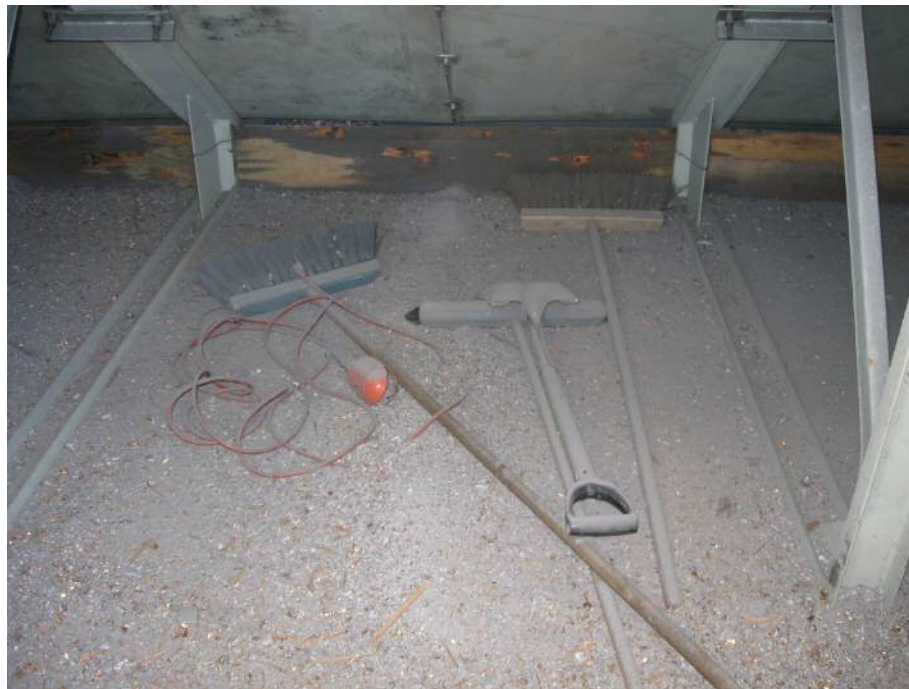
Under bullet trap with spent bullets

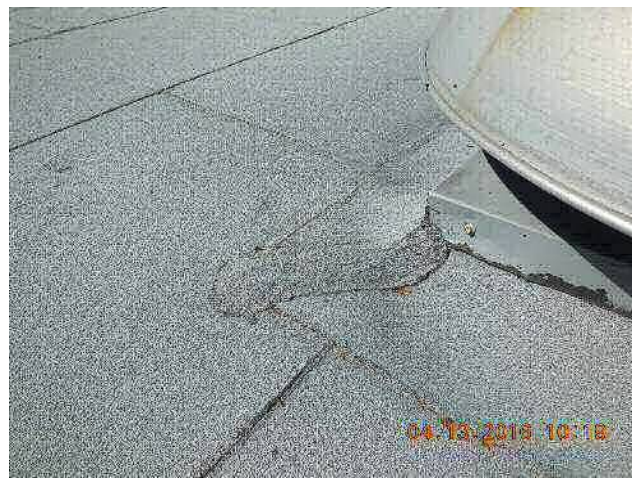
Visible Roof Discoloration at Vent

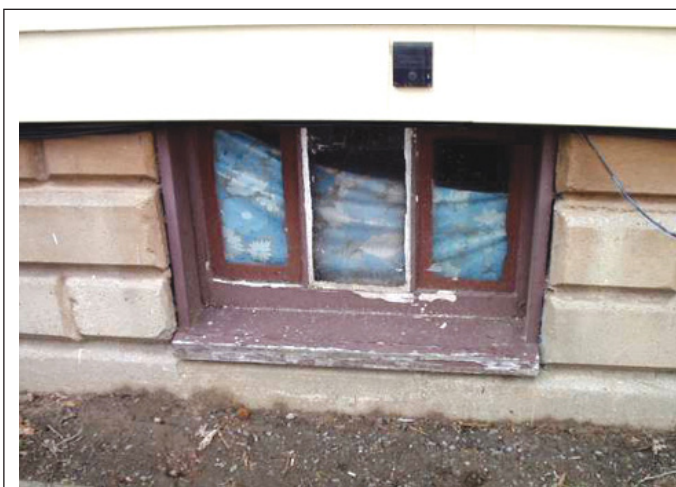
FIGURE 6.3 An area of bare soil beneath a window with deteriorated paint.

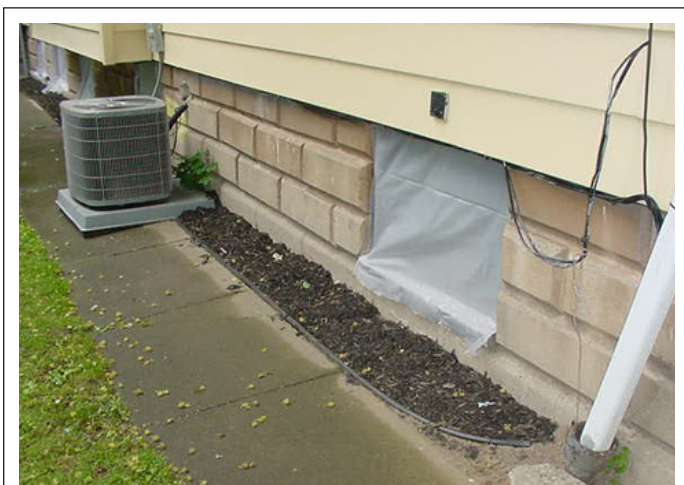
FIGURE 6.4 Bare soil in Figure 6.3 covered with mulch (the window was sealed during the process of controlling the bare soil).

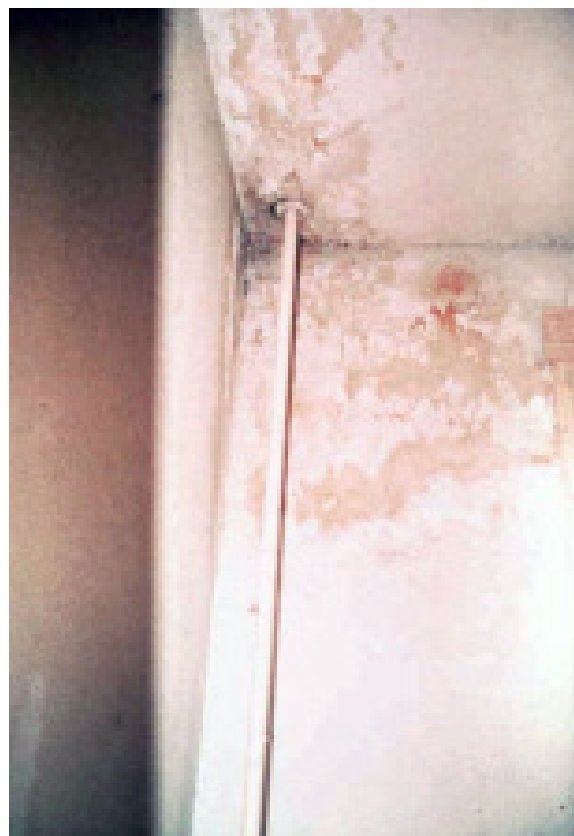
FIGURE 13.2 Deteriorated paint on surfaces that are unsuitable for encapsulation

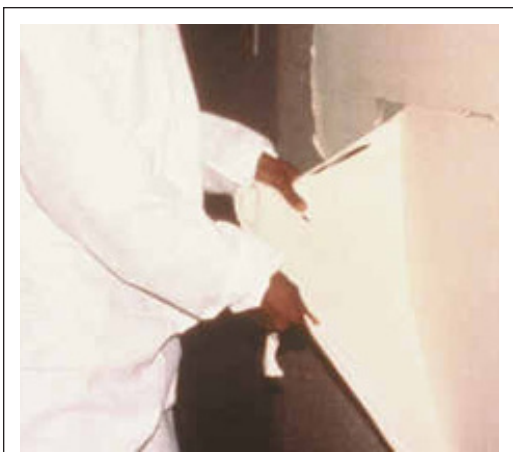
FIGURE 13.4 Encapsulant failure.
