**AEROJET**  
Environmental Remediation

**Composite Map Showing Extent of TCE, Perchlorate and NDMA Associated with Aerojet Sacramento Site, IRCTS and White Rock North Dump,**

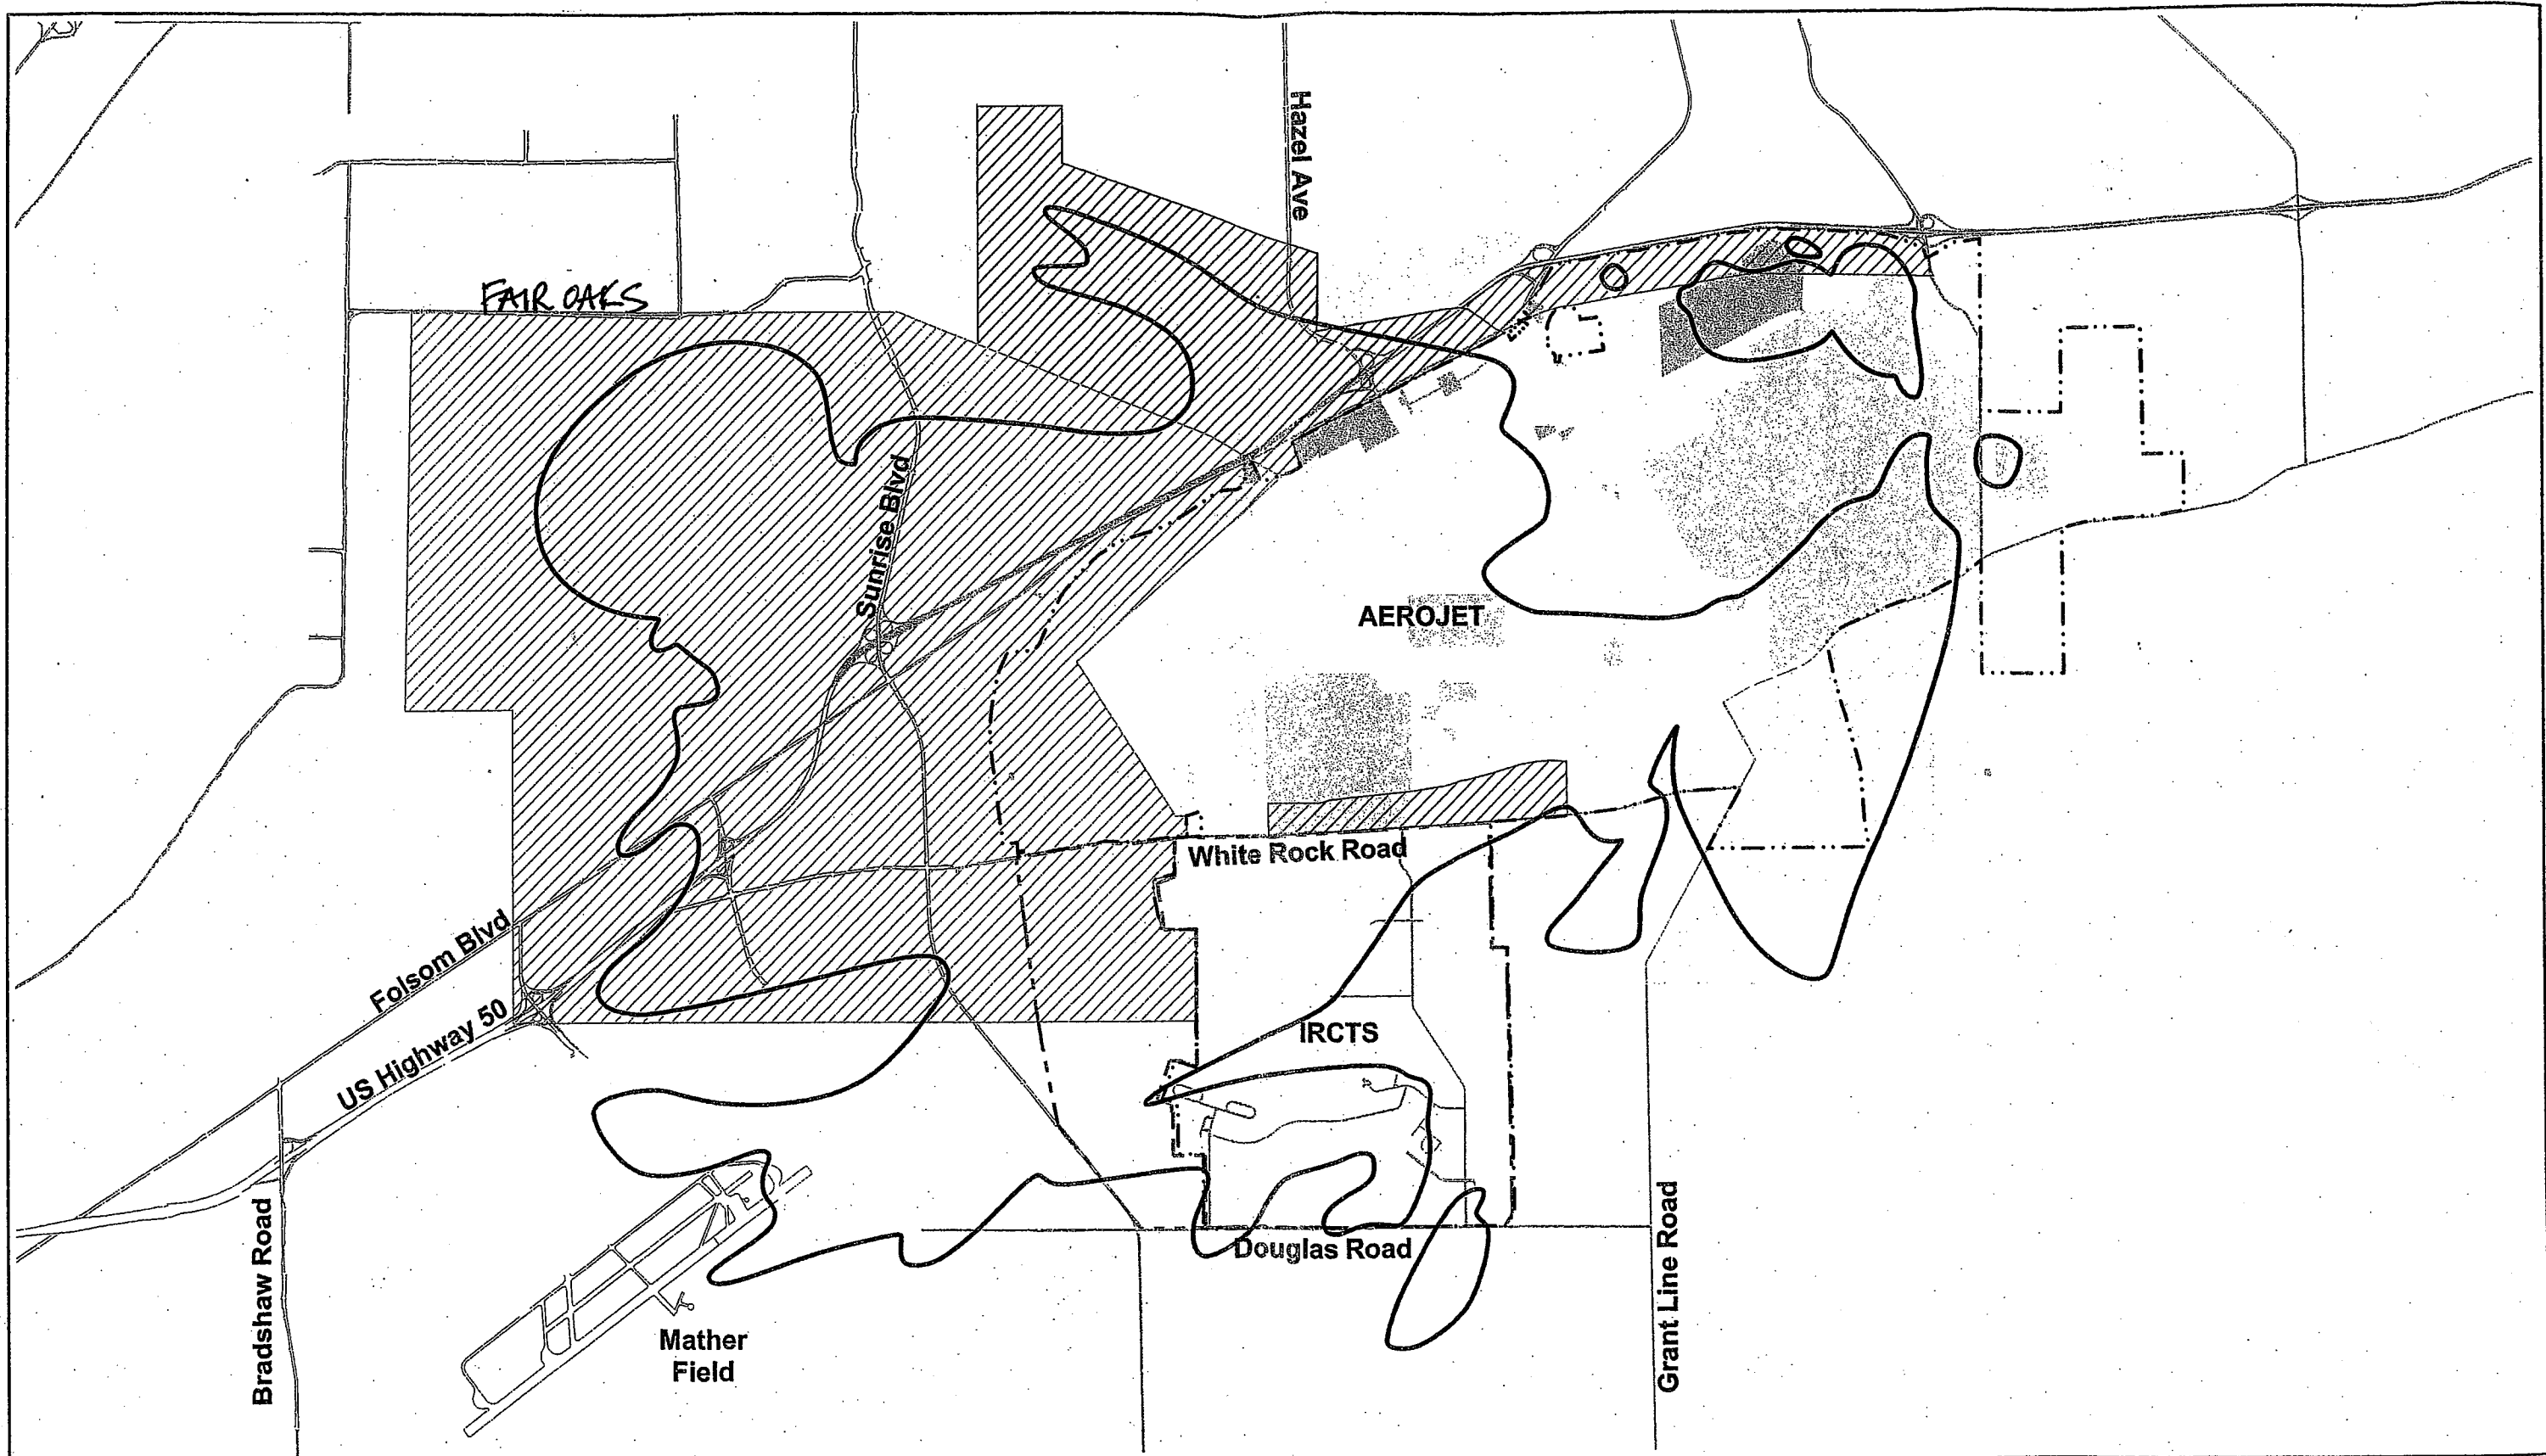
**FIGURE 1**

- Extent of Plume  
Perchlorate ≥ 6 ppb  
TCE ≥ 5 ppb  
NDMA ≥ 10 ppt
- Aerojet Property Boundary
- Inactive Rancho Cordova Test Site (IRCTS) Boundary
